Carquinez Replacement Bridge Project

Report of Potential Construction Impediments Observed in the Maritime Archaeology Remote Sensing Survey and Ground Truthing Operations

**Prepared by:
William Self Associates
Orinda, California
December 1999**

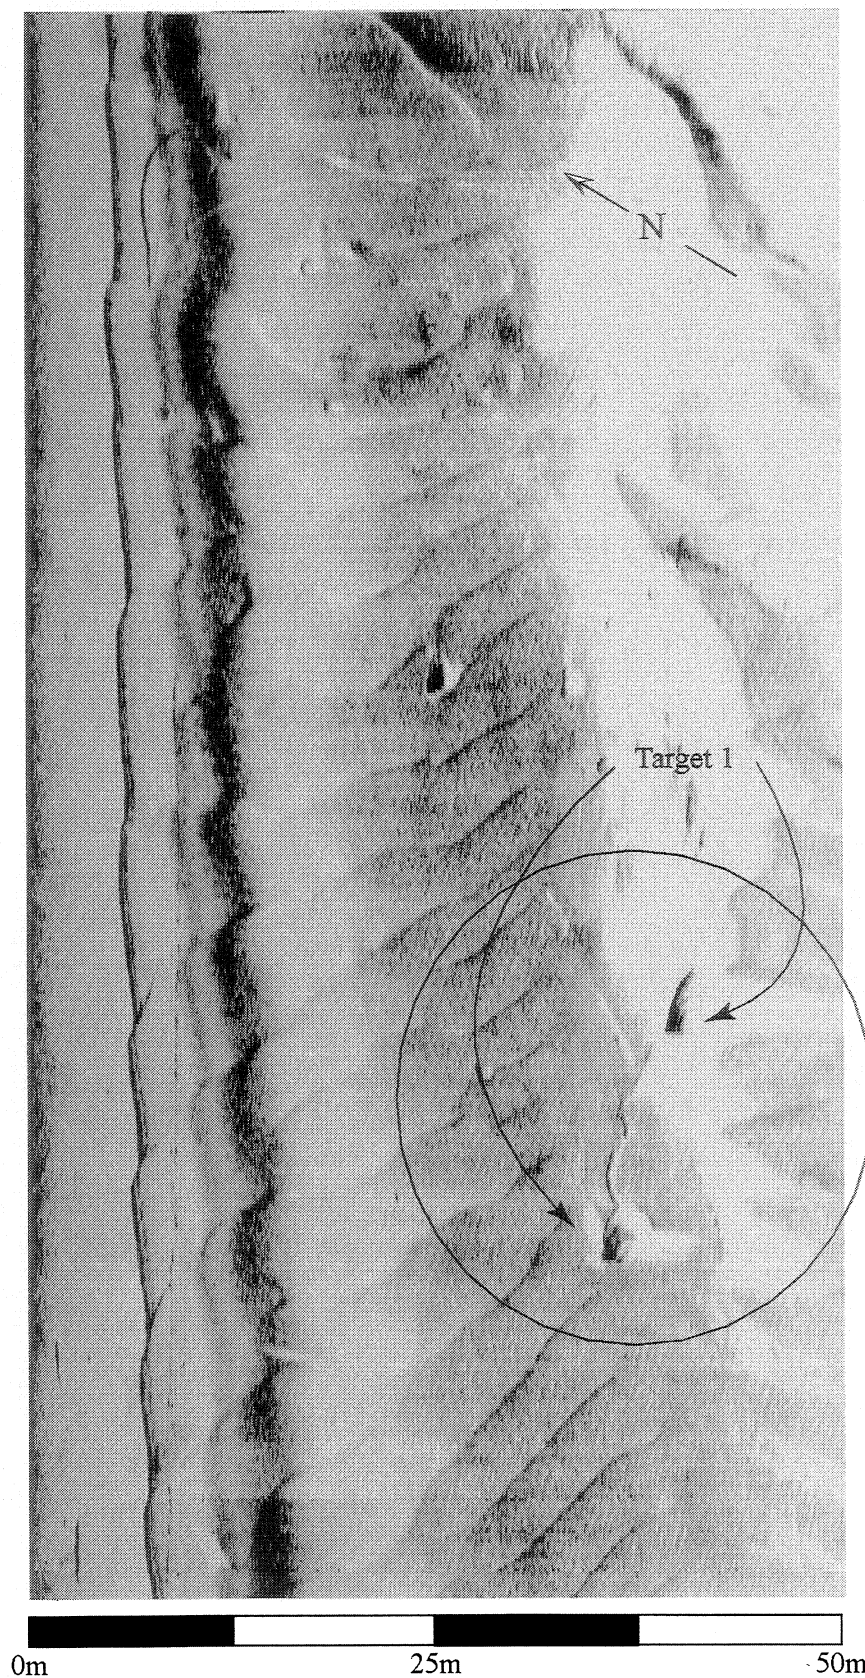
Figure 3
Carquinez Straits Potential
Construction Impediments

Acoustic target 1 was identified as the anchor and anchor cable for green buoy number #3, marking the north side of the Bulls Head Shipping Channel (Figure 3). It was not investigated.

Acoustic Target 1
(600 kHz View from Starboard Channel)

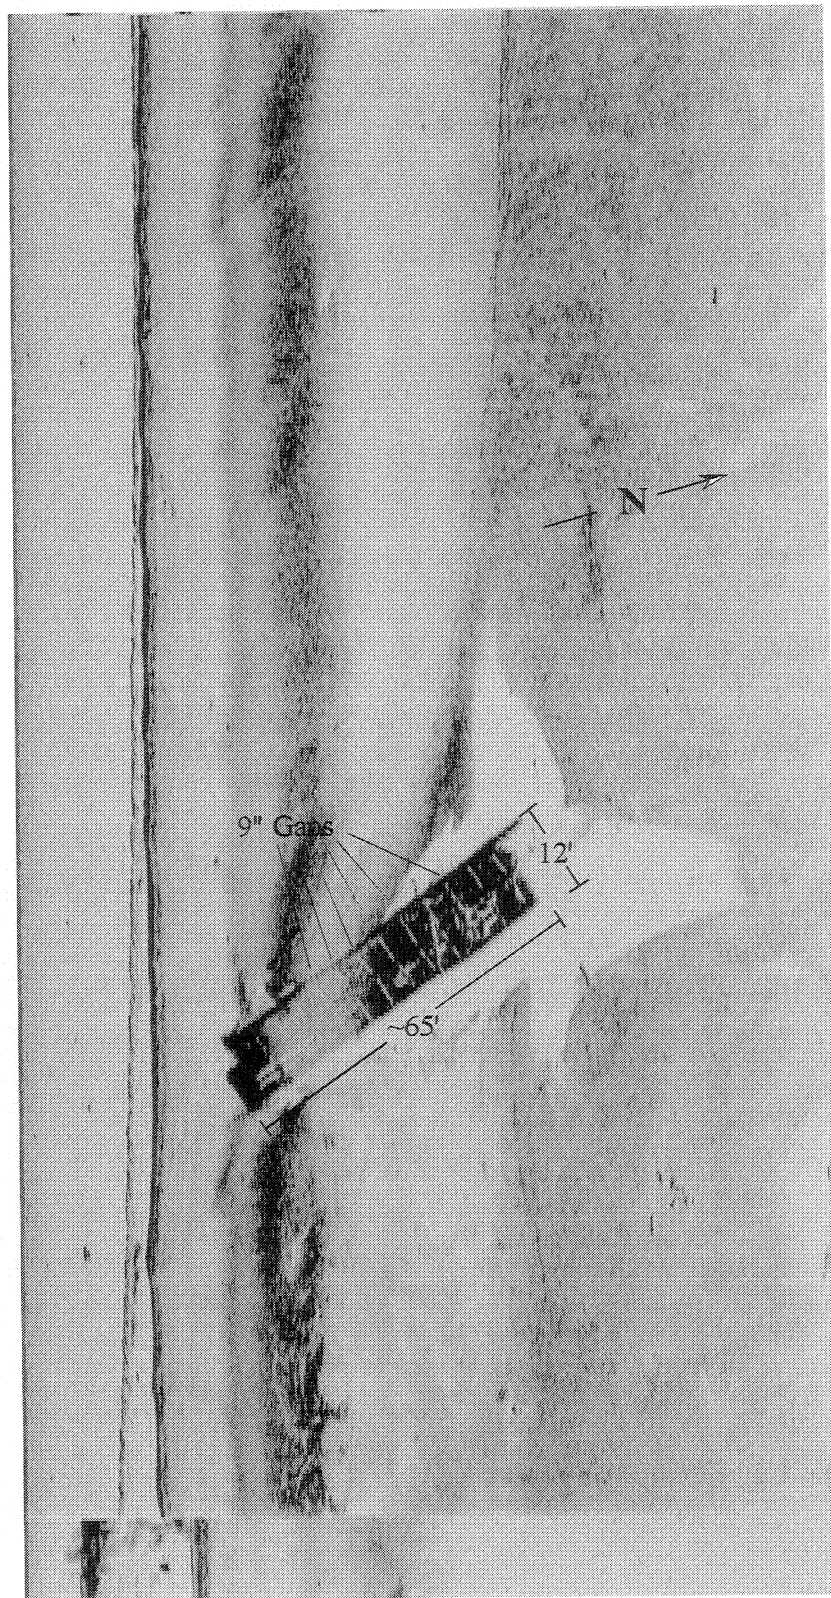
Figure 4
Carquinez Straits Potential
Construction Impediments

Acoustic target 3 is a rectangular, steel object that generates a magnetic signature of 1,775 gammas (γ). Although it was not possible to visually ascertain what the object is, tactile evaluation determined that it is probably fabricated from steel and measures approximately 65-feet in length and 12-feet in width (Figures 4 and 5). The object comprises a series of at least 12 rectangular boxes or cells, lying side-by-side, each of which measures 5-feet in length, 12-feet in width, and 6-feet in height. Each cell is separated from its neighbor by a space of approximately 9-inches. The cells are held in place by a length of 10-inch x 15-inch angle iron that runs along the length of each side of the object. A strip of 10-inch wide steel runs down the center of the rectangle, across the horizontal surface of each cell. The bottom of each cell - that is, the surface of the cell lying on the bottom sediment, appears to be solid, like the top.

A length of heavy steel cable is wrapped through two substantial "eyes," set perpendicular to each other and fastened to the horizontal surface of one of the cells. Projecting from the northwest side of the rectangle is a wood pole, approximately 10-inches in diameter. It may be intrusive and could possibly be a log that has become lodged in the wreckage. It was not possible to determine its length, but analysis of the sonar record suggests it may be 15-18 feet in length.

The 10-inch x 15-inch angle iron brace that runs along the eastern side of the rectangle projects beyond the last attached cell, suggesting a portion of the structure has broken off. An object

Acoustic Target 3
(600 kHz View from Starboard Channel)

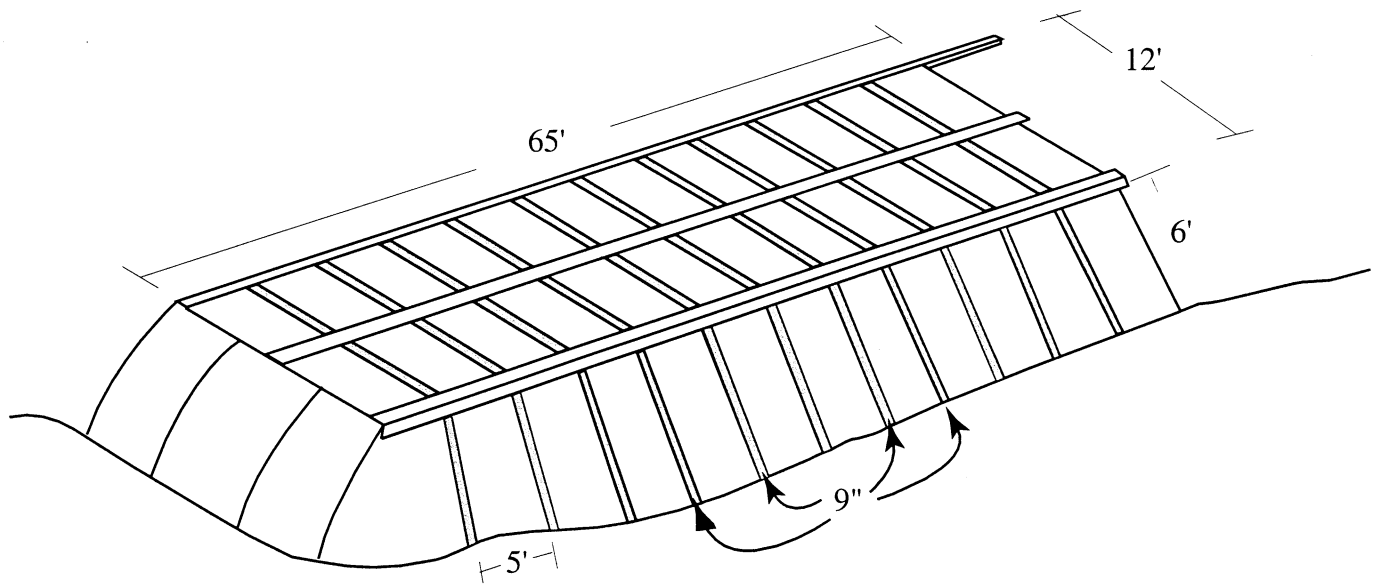
Figure 5
Carquinez Straits Potential
Construction Impediments

Perspective Drawing of Acoustic Target 3

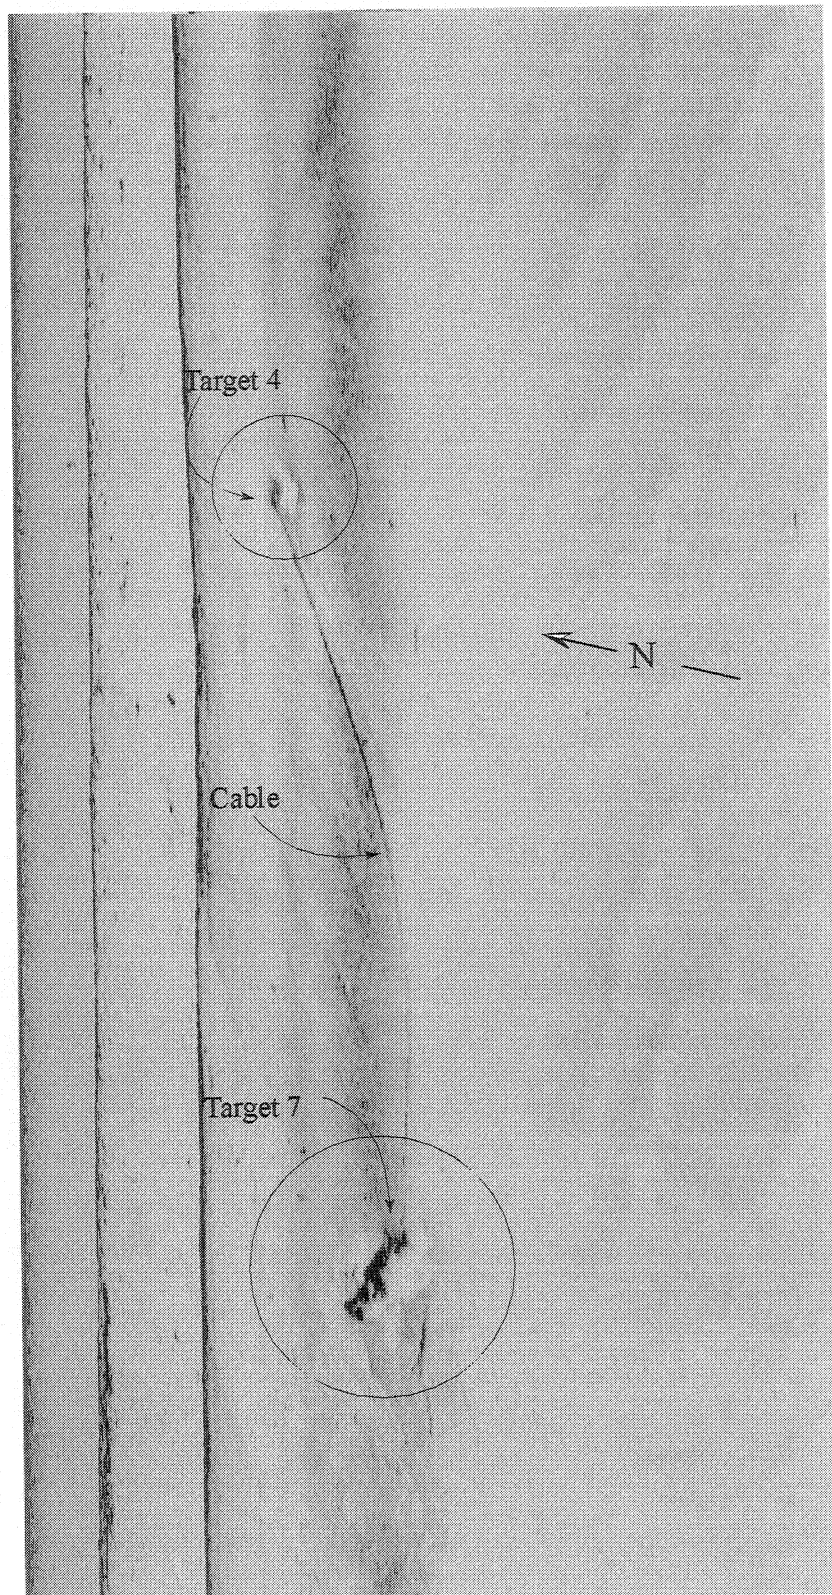
Figure 6
Carquinez Straits Potential
Construction Impediments

Acoustic target 4 is an anchoring device with a length of attached cable that runs along the bottom of the Strait towards the west for a distance of approximately 150-feet. At its western end, the cable is attached to an object identified as target 7. It appears to be a sunken navigation buoy. The target is approximately 15-feet in height with a small counterweight attached to the bottom (Figures 6, 7, and 7a). Metal flanges or “sails” project from its opposite end. The target did not generate a magnetic signature, which is consistent with an object fabricated from aluminum, as a buoy would be. The mass of target 7 projects above the bottom surface approximately 5-feet.

Acoustic Targets 4 and 7
(600 kHz View from Starboard Channel)

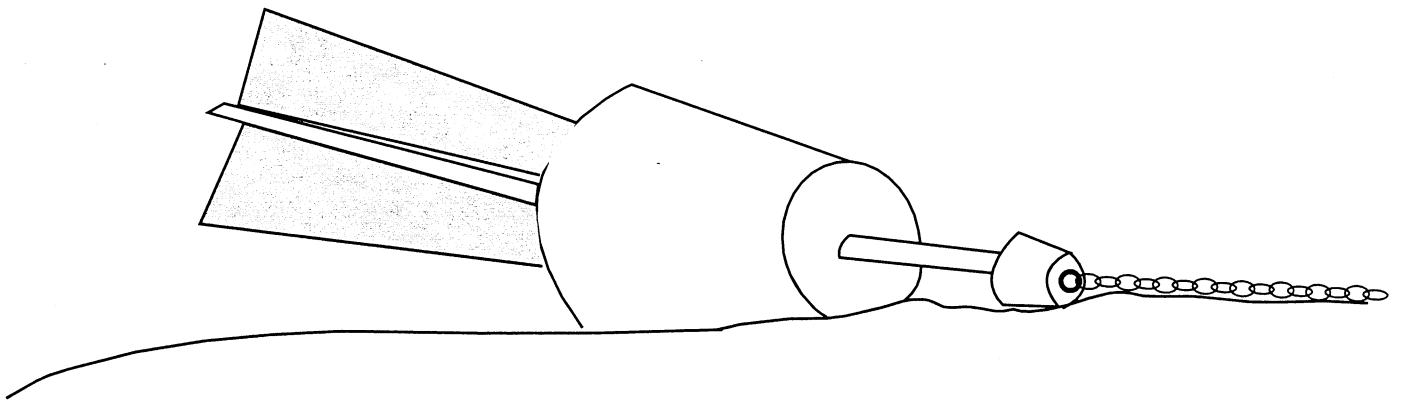
Figure 7
Carquinez Straits Potential
Construction Impediments

Perspective Drawing of Acoustic Target 7

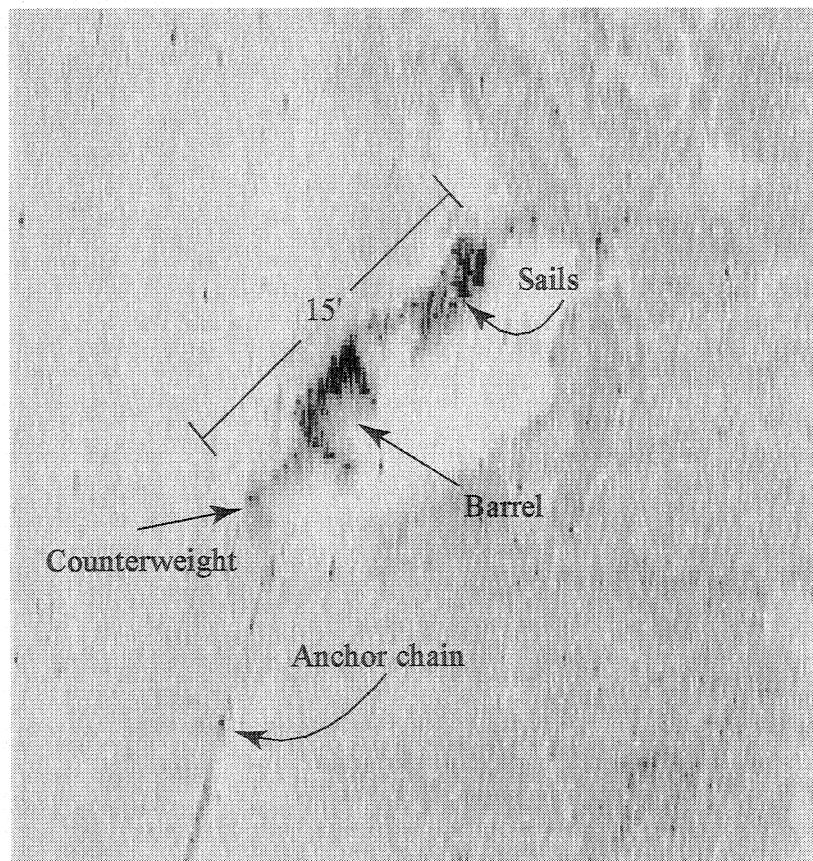
Figure 7a
Carquinez Straits Potential
Construction Impediments

Detail: Acoustic Target 7
(600 kHz View from Starboard Channel)

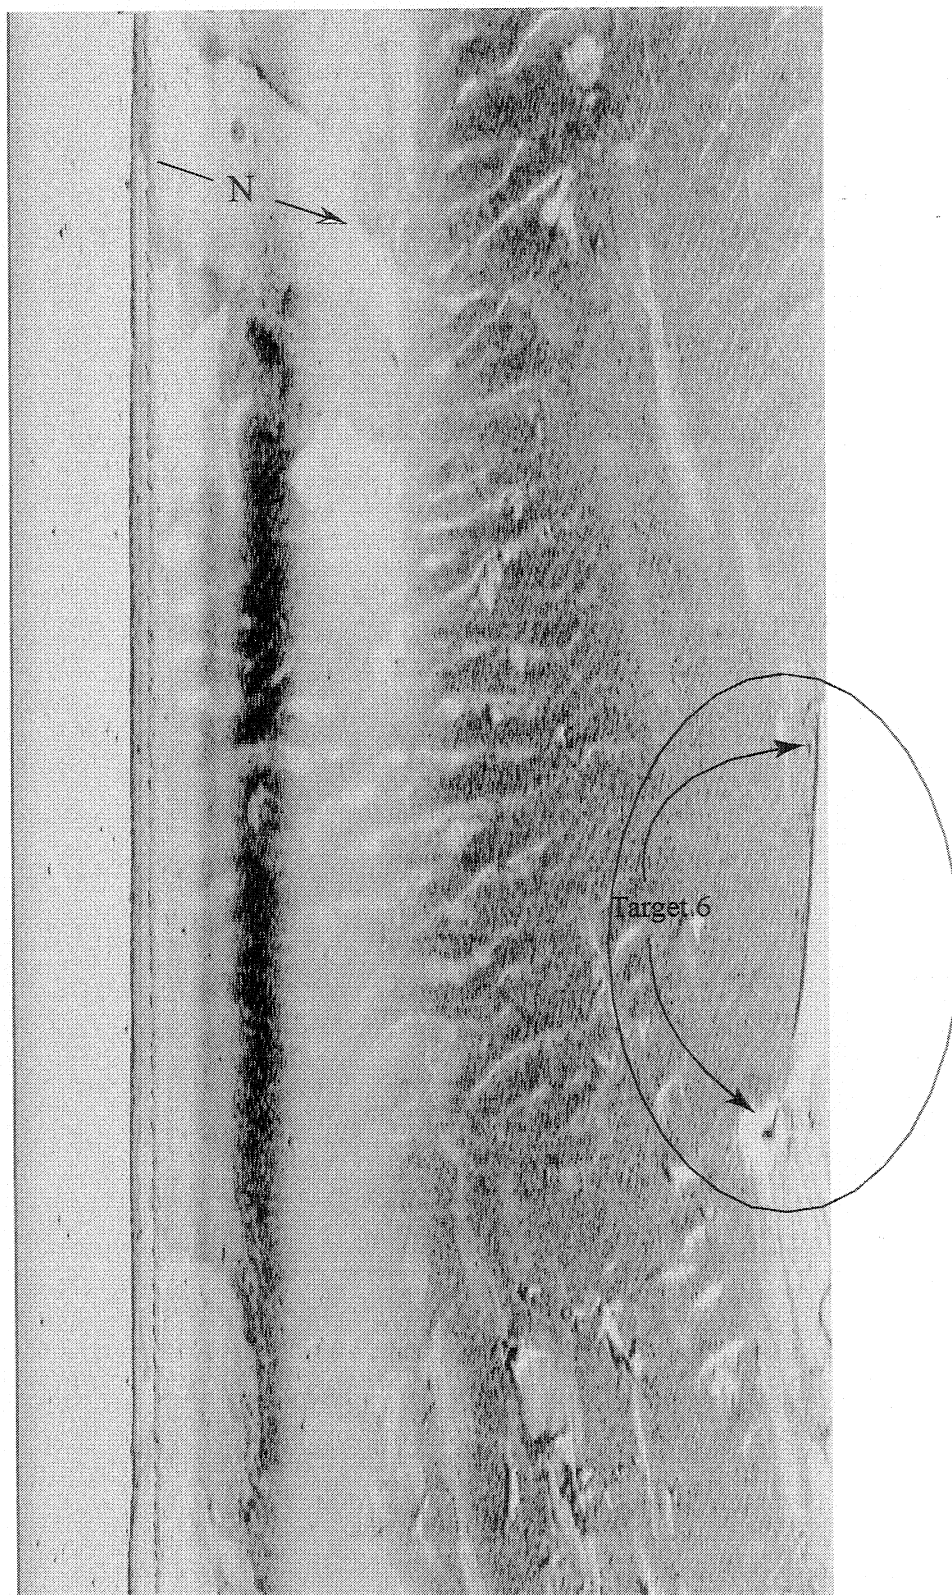
Figure 8
Carquinez Straits Potential
Construction Impediments

Acoustic target 6 appears to be at least one, and possibly two, lengths of anchor cable lying partially buried beneath the surface of the bottom sediments. The target has a magnetic signature of 400γ. The cable may be looped around itself, or it may be two distinct pieces. One length measures approximately 65-feet in length, the other measures approximately 10-feet in length. This target was not investigated during the ground truthing operation (Figure 8).

Acoustic Target 6
(600 kHz View from Starboard Channel)

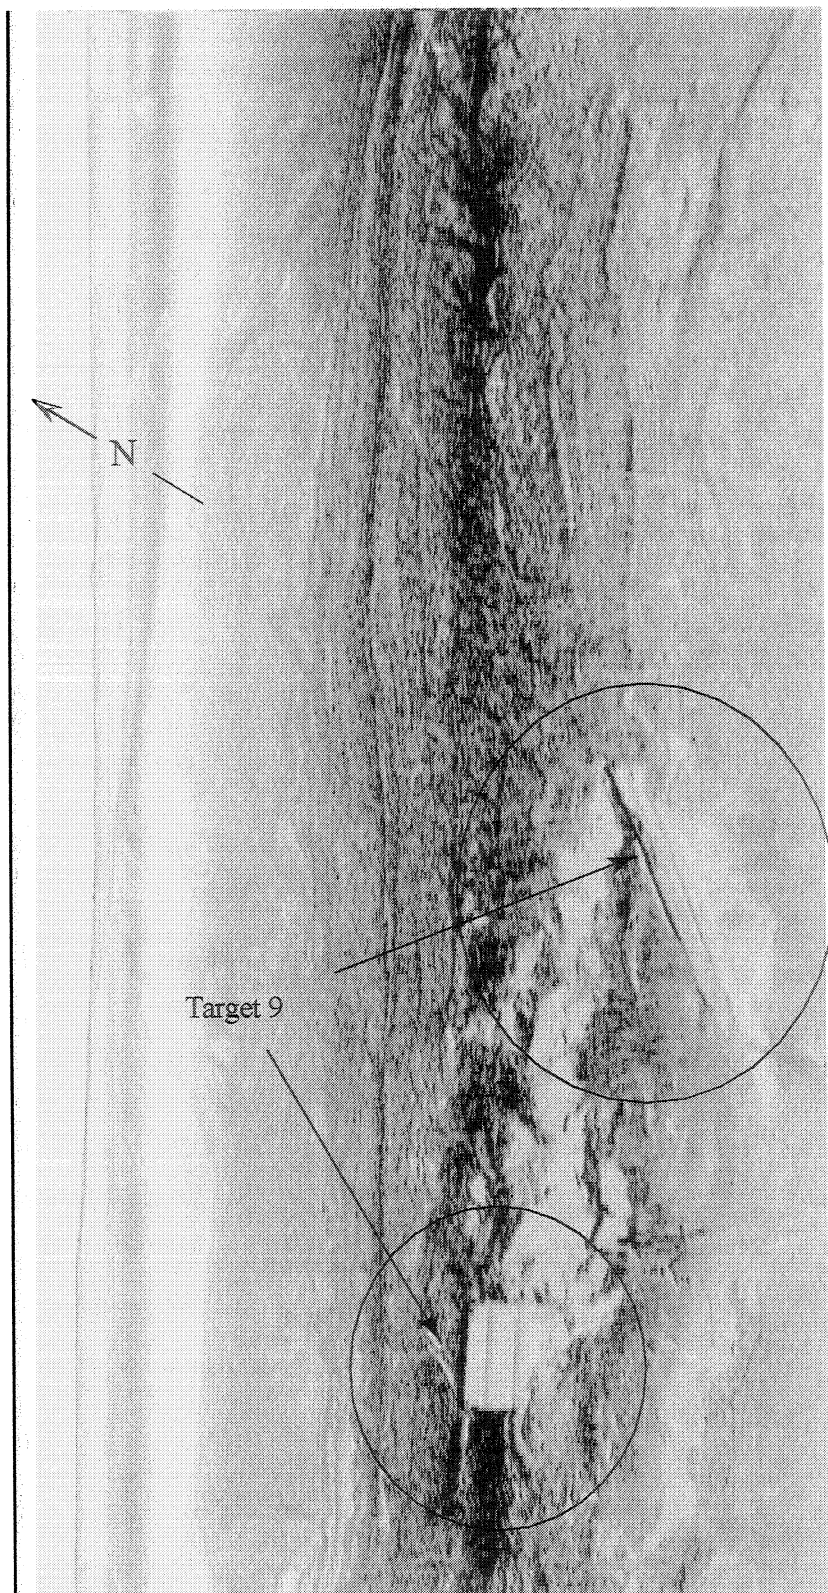
Figure 9
Carquinez Straits Potential
Construction Impediments

Acoustic target 9 comprises three linear objects that generate a magnetic signature of 1,975γ. The westernmost object is approximately 22-feet in length and projects above the bottom surface approximately 3-feet. Two linear objects are situated to the east, one of which is approximately 35-feet in length; the other is approximately 45-feet long. The latter two project above the bottom surface approximately 3.5-feet (Figure 9).

Acoustic Target 9
(600 kHz View from Starboard Channel)

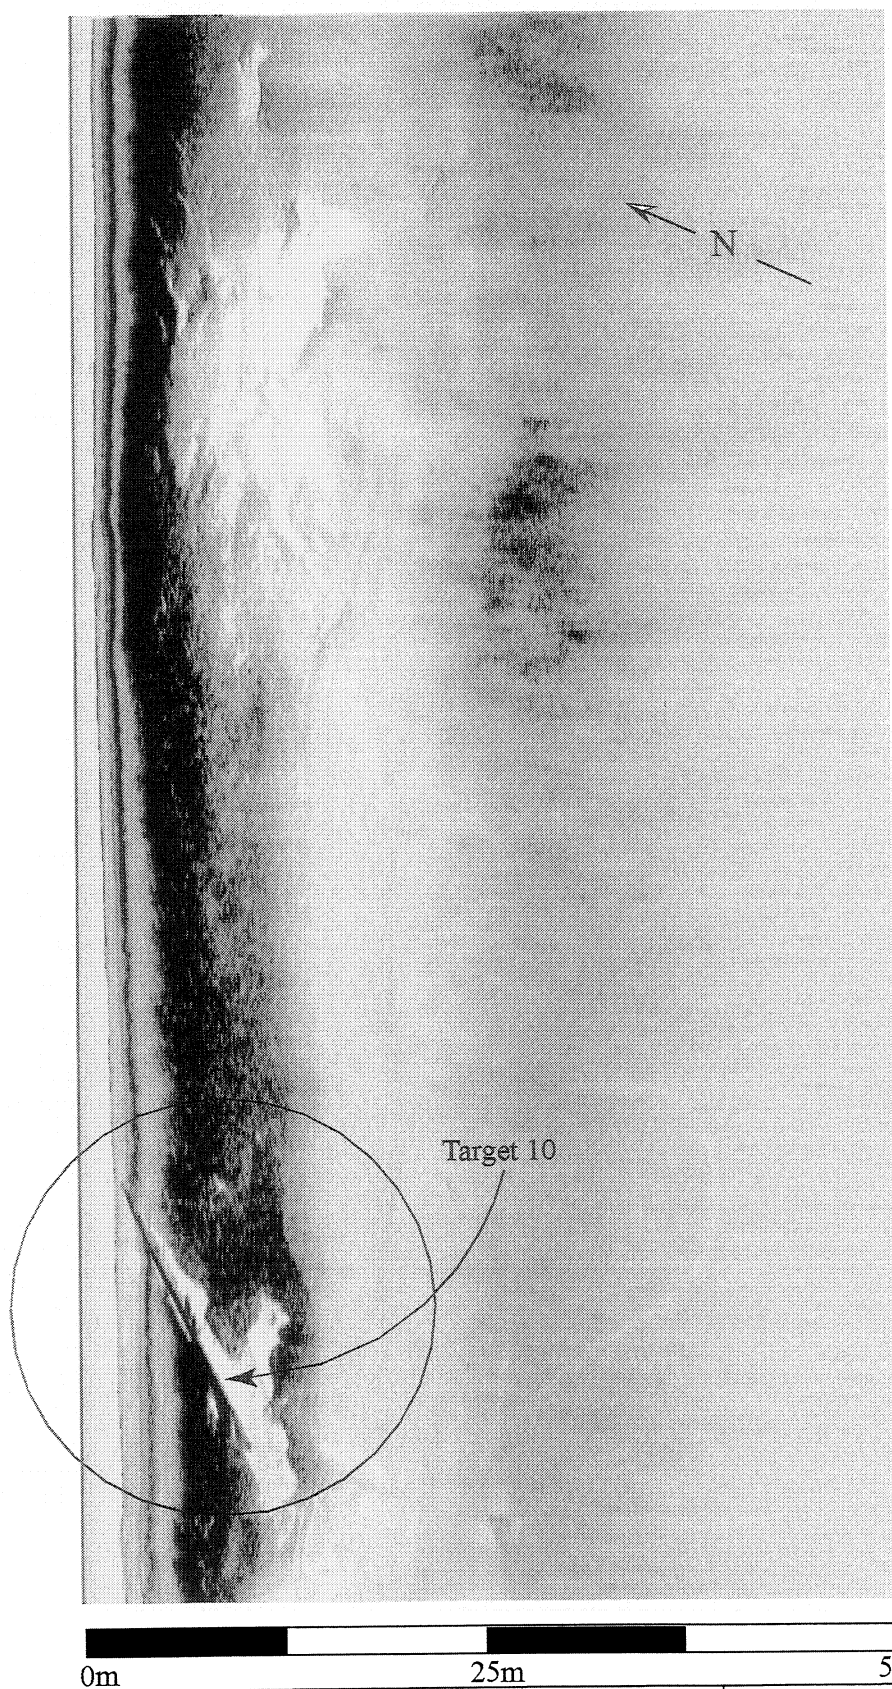
Figure 10
Carquinez Straits Potential
Construction Impediments

Target 10 is a similar type of linear object. It is approximately 25-feet in length, projects above the bottom surface approximately 2.5 feet, and generates a magnetic signature of a 475γ. Targets 9 and 10 are probably abandoned or lost lengths of dredge pipe (Figure 10).

Acoustic Target 10
(600 kHz View from Starboard Channel)

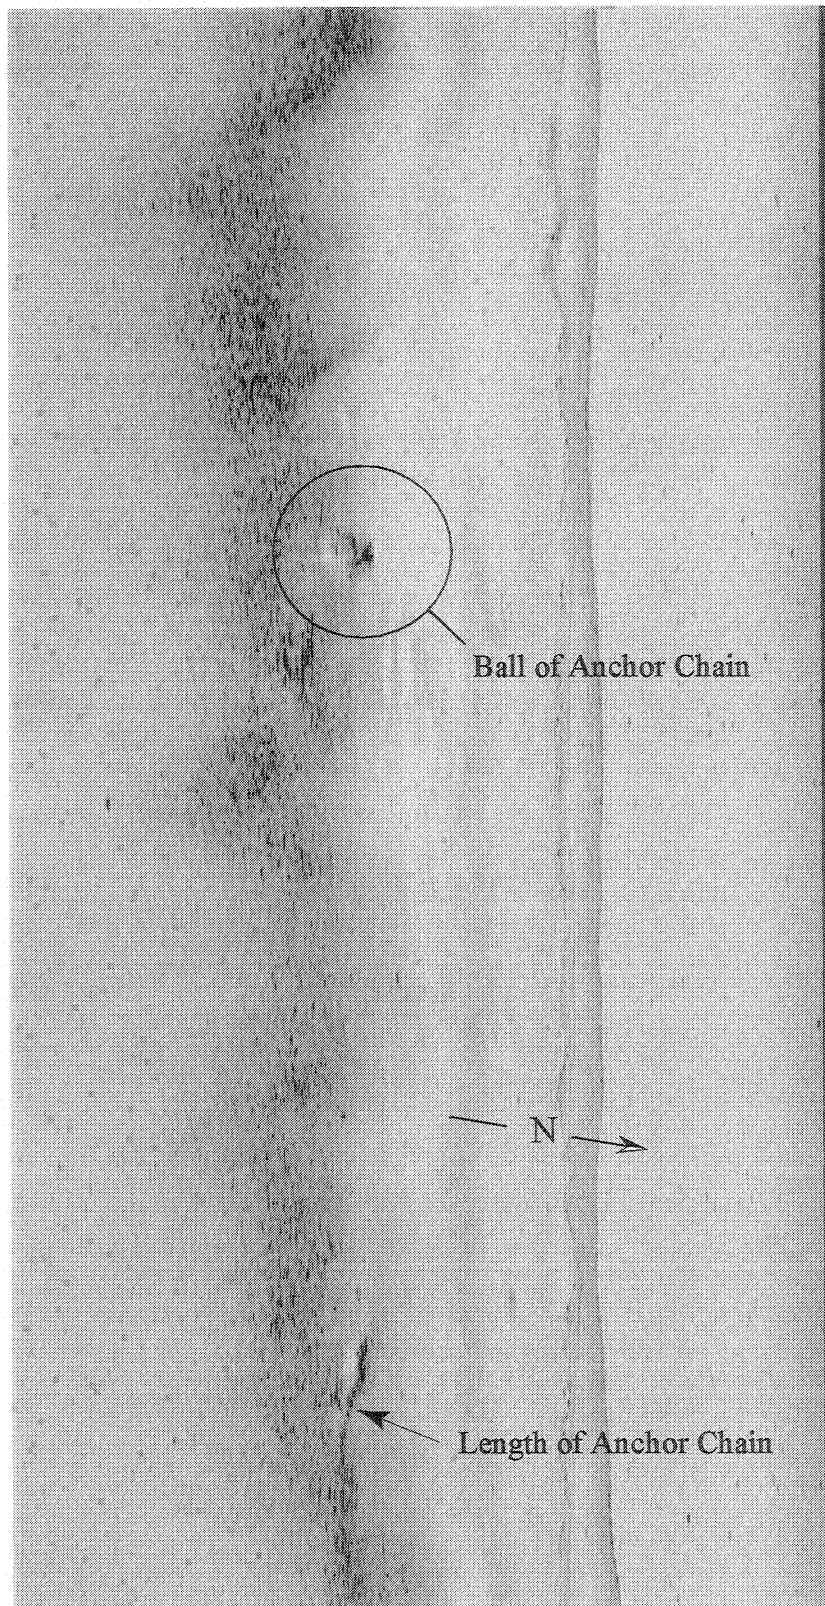
Figure 11
Carquinez Straits Potential
Construction Impediments

Magnetic target 1 has a signature of 500γ and lies approximately 500-feet west of acoustic/magnetic target 3 (refer to Fig 1). The surficial expression of the target is very subtle and it was not observed in the initial side scan sonar survey. The target was therefore initially classified as a magnetic target only, and not an acoustic target. It was not until the ground truthing phase, when the location of the target's magnetic signature was reexamined, that the configuration of the target was observed in the sonar record. The target appears to consist of two components, separated by approximately 40-feet. The western component is a large ball of stud-link anchor chain approximately 3-feet in diameter, with approximately 5-feet of chain trailing off to the west. Each link of the chain appeared to be approximately 10-inches long and 2.5-inches thick. The eastern component of magnetic target 1 appears to be a length of cable or chain approximately 20-feet long. The two components may actually be one long length of chain that is largely covered by the bottom sediments and exposed only at either end (Figure 11).

Magnetic Target 1
(600 kHz View from Port Channel)

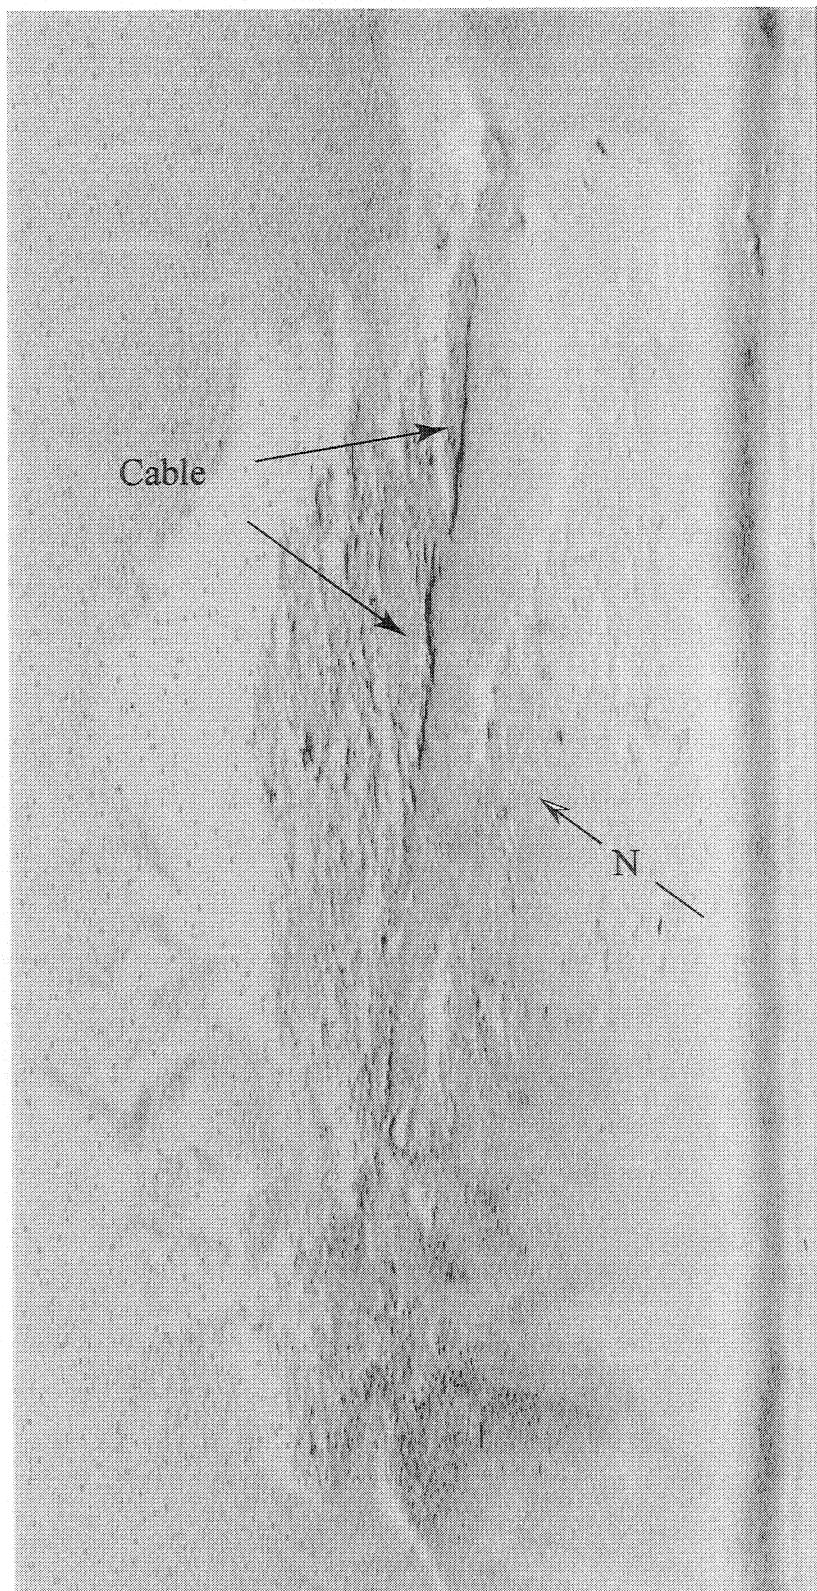
Figure 12
Carquinez Straits Potential
Construction Impediments

This target generates a magnetic signature of approximately 250γ and lies approximately 300-feet north of debris field 4. It appears to be a length of cable approximately 75-feet long. The surficial expression of the target is very subtle and it was unobserved in the initial side scan sonar survey. The target was therefore initially classified as a magnetic target only, and not an acoustic target. It was not until the ground truthing phase when the location of the target's magnetic signature was reexamined that the configuration of the sinuous cable was observed in the sonar record (Figure 12).

Magnetic Target 3
(600 kHz View from Port Channel)

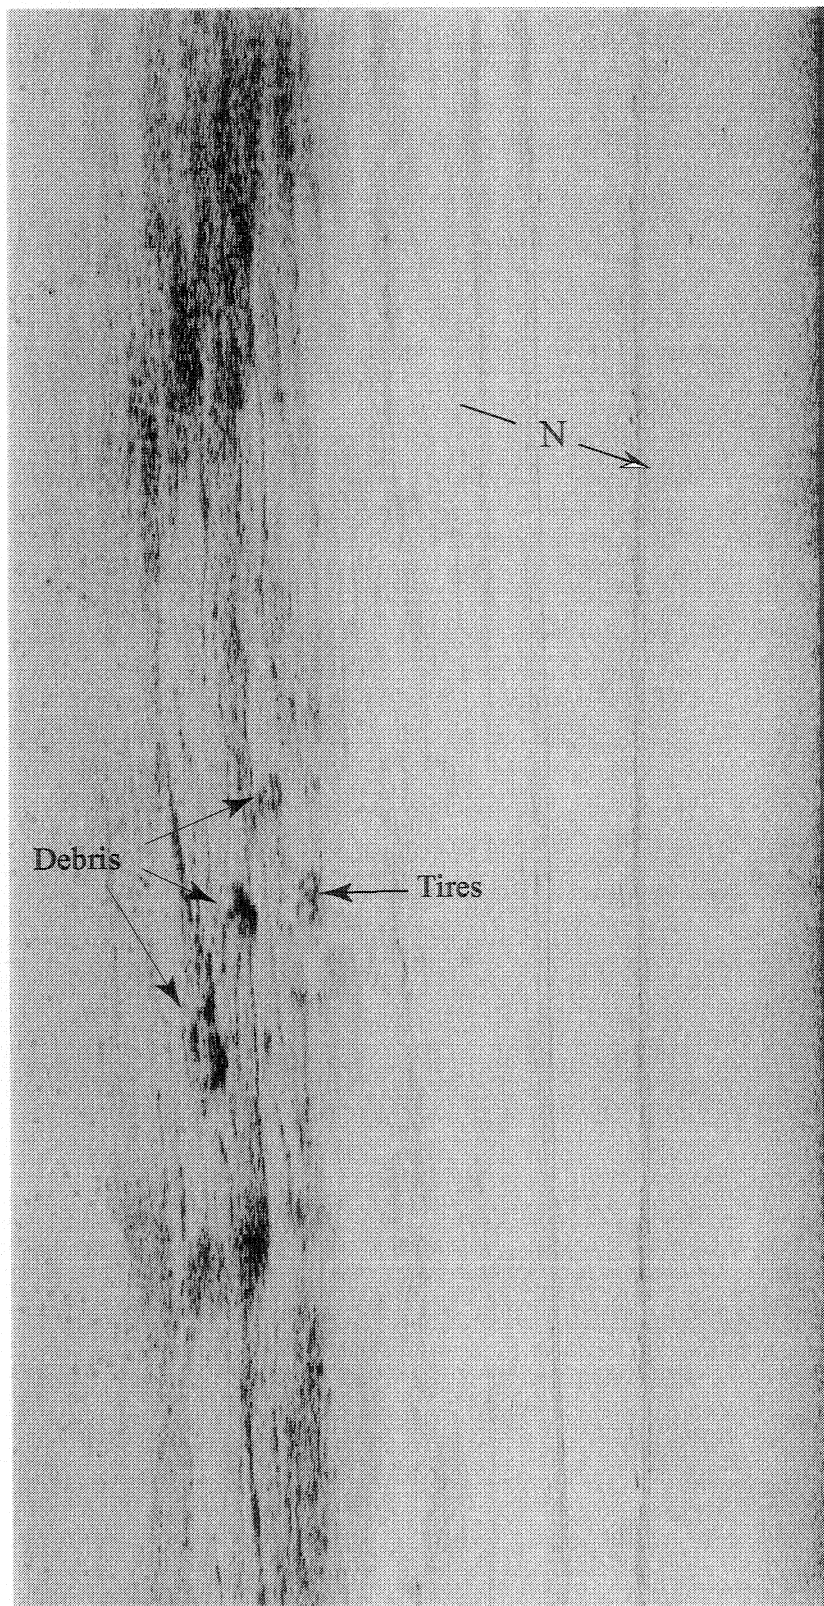
Figure 13
Carquinez Straits Potential
Construction Impediments

This scatter of cultural material appeared to be composed of at least five discarded tires and several pieces of isolated debris that appeared to be discarded automobile parts. No other cultural material could be found during the tactile investigation of the bottom sediment (Figure 13).

Debris Field 2
(600 kHz View from Port Channel)

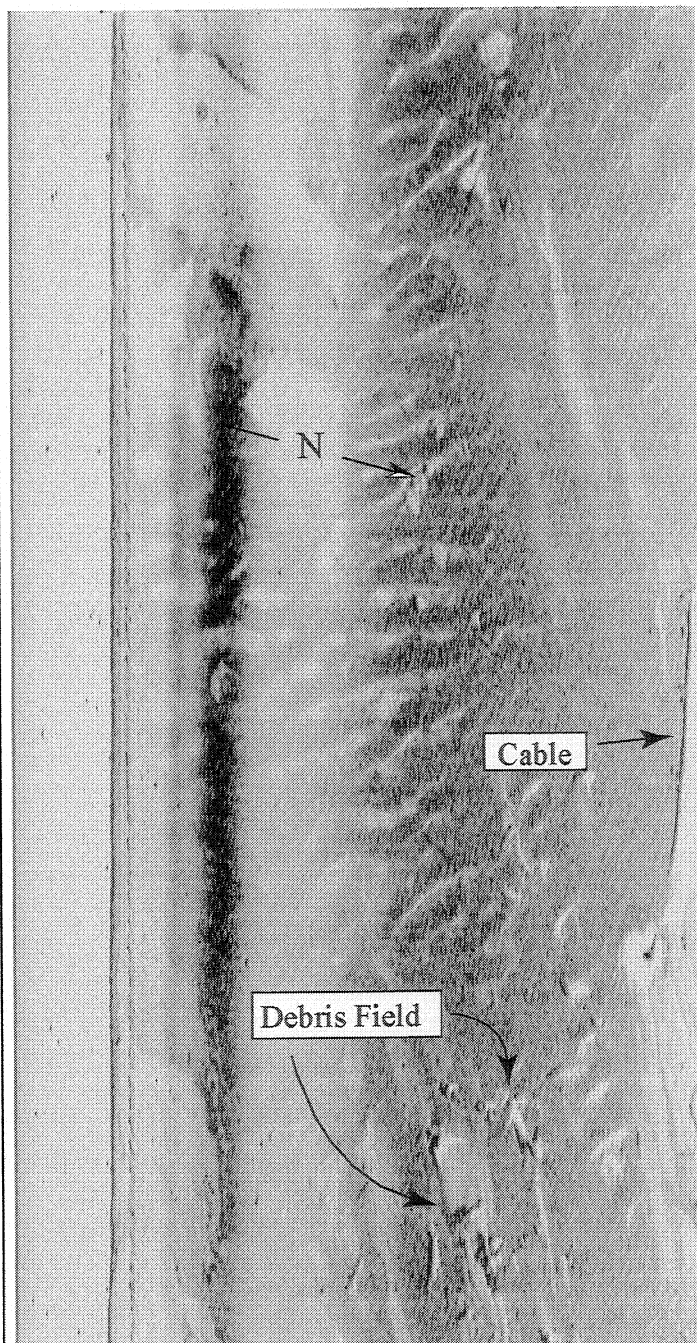
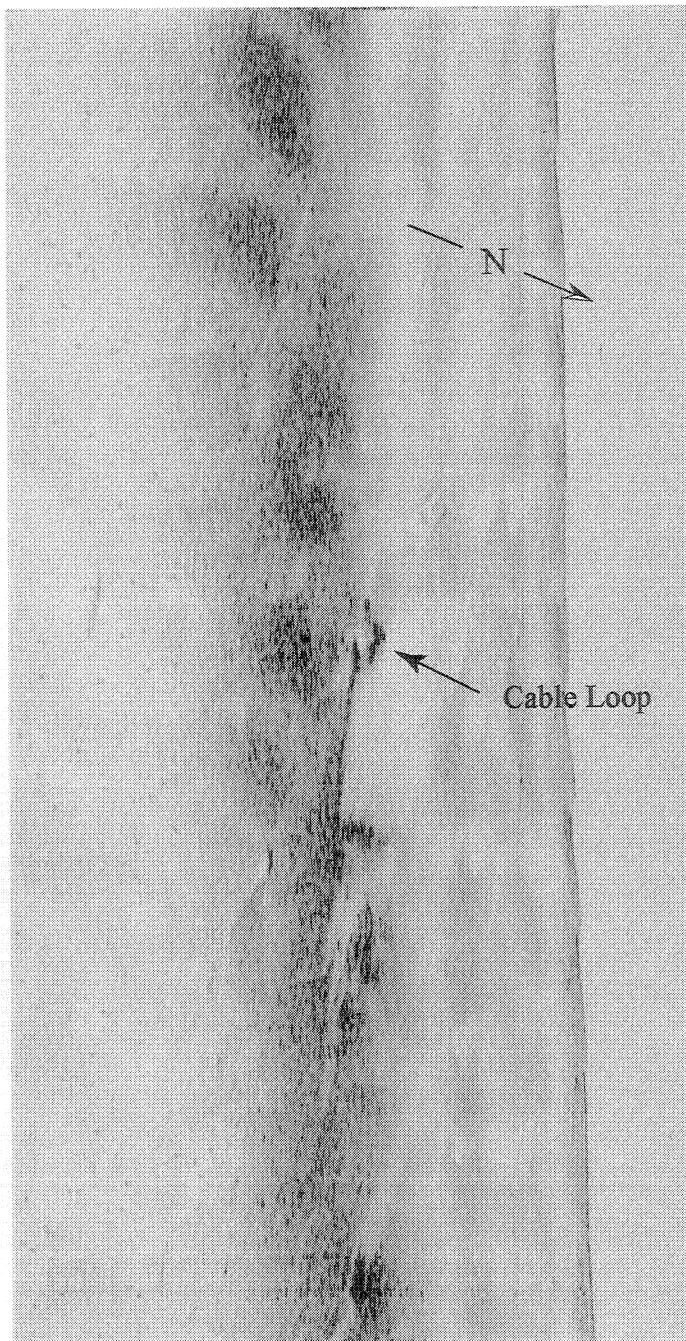
Figure 14
Carquinez Straits Potential
Construction Impediments

Examination of this debris field revealed that a scatter of small to medium-size sheets of metal lie interspersed below and on top of a segment of steel cable that appeared to be approximately

5-inches in diameter. The cable is looped back upon itself and is partially buried in the bottom sediments. The straight, exposed portion of the cable appears to be approximately 25-feet long (Figure 14).

Debris Field 3
(600 kHz View)

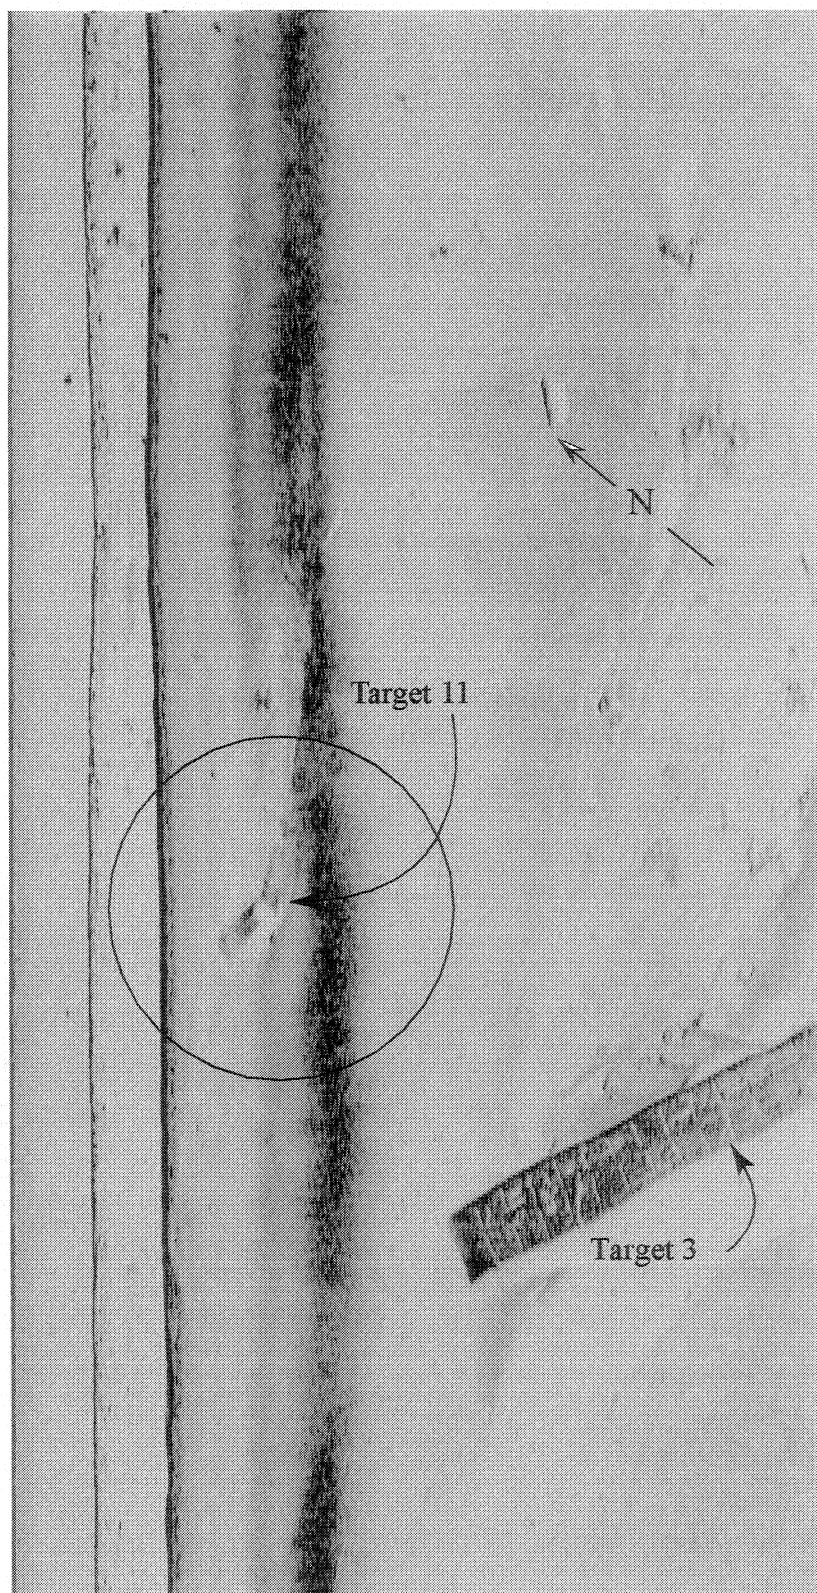
Figure 15
Carquinez Straits Potential
Construction Impediments

observed in one of the sonar records during subsequent ground truthing operations appears to be a portion of one of the cells, perhaps one that broke off from this end (see target 11 and Figure 15). Subsequent ground truthing of target 11 confirmed it could possibly be such a piece of the wreckage.

During the side scan sonar survey of debris field 3, a previously unobserved rectangular object was identified immediately adjacent to the scatter of debris that constituted the debris field. Examination of the acoustic data and a subsequent ground-truthing investigation of the target determined that target was a trapezoidal-shaped metal object that appeared to be fabricated of steel plating. Designated as Target 11, the object appeared to be approximately 5-feet wide and 4-to-5 feet in height. Its close proximity to target 3 and the similarity of size and shape suggest it is a portion of target 3 that broke free (Figures 15 and 15a).

Acoustic Target 11
(600 kHz View from Starboard Channel)

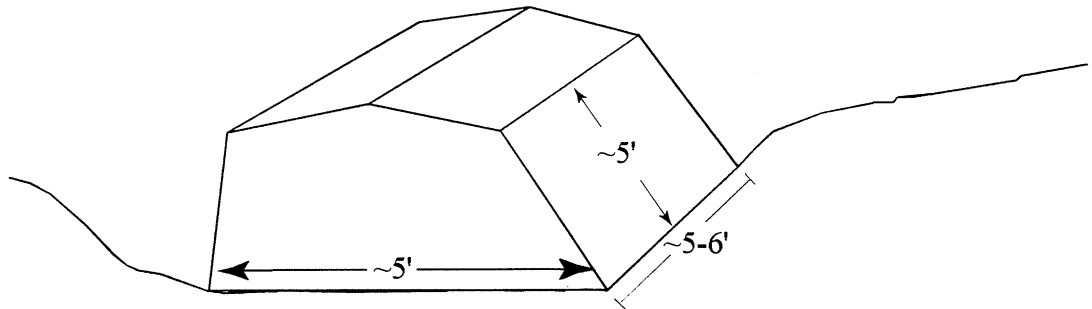
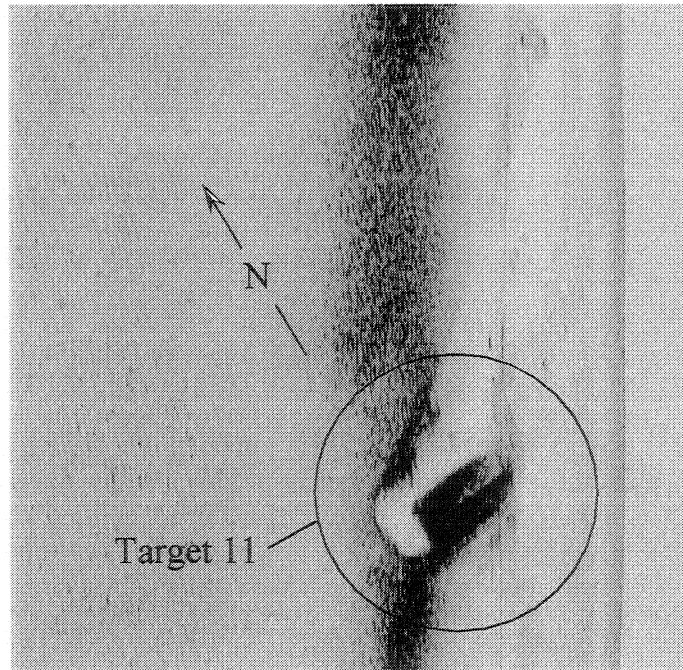
Figure 15a
Carquinez Straits Potential
Construction Impediments

Perspective Drawing and Detail of Acoustic Target 11

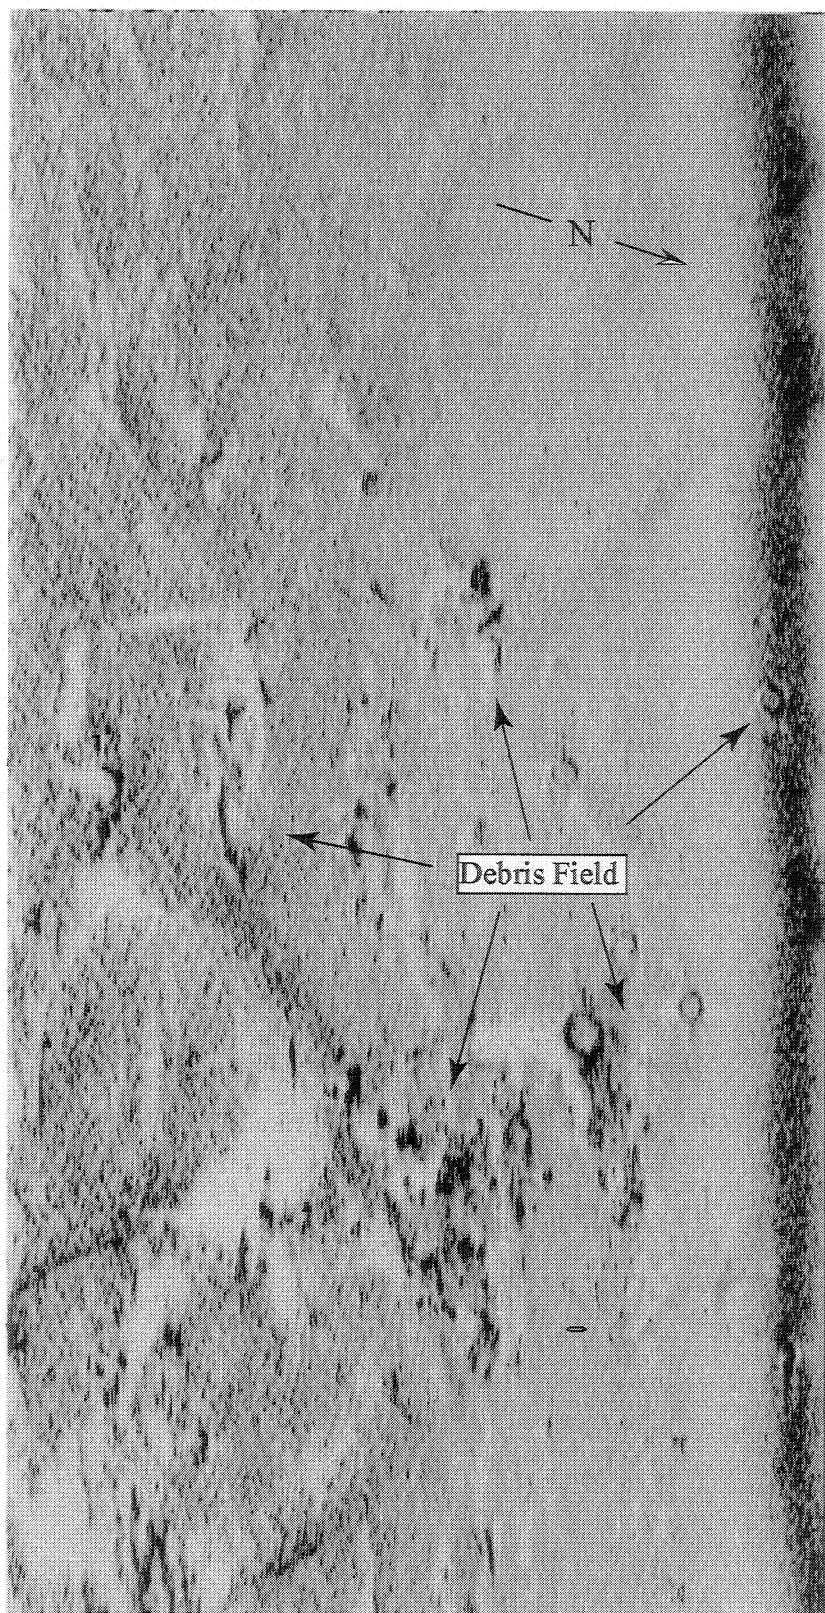
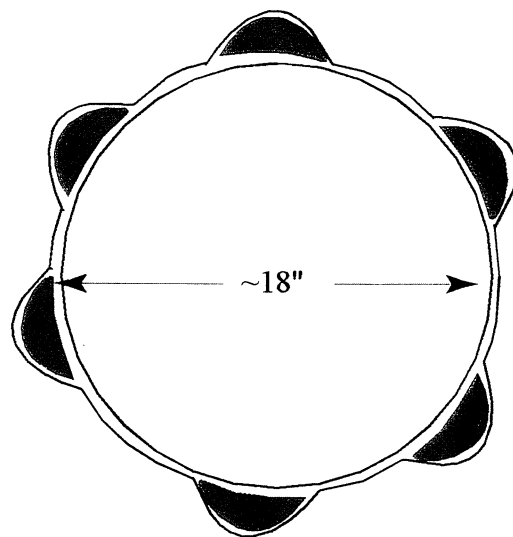
Figure 16
Carquinez Straits Potential
Construction Impediments

The debris comprising this field comprised a variety of metal blocks, steel plates, and a number of unidentifiable metal parts, wood fragments, at least one tire, and a solid, circular metal object, approximately 18-inches in diameter, with projecting metal teeth. The edges of the teeth are ridged and the inside surfaces are concave. Its exact nature and function could not be determined (Figure 16).

Debris Field 4
(600 kHz View from Port Channel)

Detail of Circular Object
